VOL. 7

NO. 1

SECURITY FACTS

A Physical Security Technology Newsletter

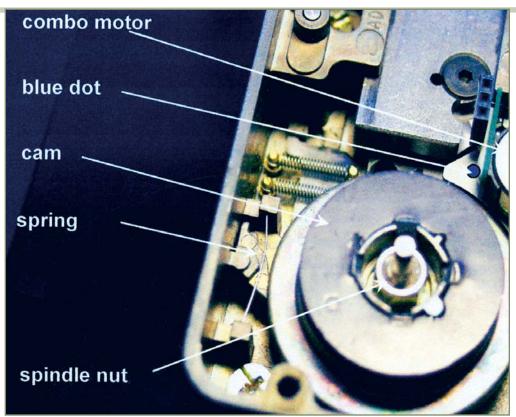
An article in the Spring 2003 issue (Volume 6, Number 2, page 4) of "Security Facts" newsletter titled "What to do if you receive a container and the dial will not spin," contains an error. The article dealt with removal of the cam pawl and its spring from the X-09 combination lock. The photograph in the article incorrectly identified the cam pawl spring as a coil spring. THAT SPRING SHOULD NOT BE REMOVED. The cam pawl spring is correctly identified in this photograph.

Many of the locks that had cam pawls also had combo motors that should be replaced. (If a lock was manufactured without a cam pawl, its combo motor does not need to be replaced.) While you have the cover off the lock, check the combo motor. If there is no blue dot at the location shown by the arrow, and if the lock was manufactured in 2002, the combo motor should be replaced. Contact the DoD Lock Program to obtain a replacement combo motor. Removing the existing motor and installing a new one will require a T8 Torx wrench.

Internal view of X-09 Combination Lock

Here is the correct procedure for removing the cam pawl spring and cam pawl. Holding the dial with one hand, remove the spindle nut with a 5/16-inch nut driver. Remove the drive cam from the spindle. Remove the cam pawl spring and the cam pawl. Replace the drive cam on the spindle. Replace the spindle nut on the spindle. Turn the drive cam so the gear teeth are near the end of the lock case (at the bottom of this photo). Brace the tip of a Number 1 Phillips screwdriver against the gear teeth of the drive cam to hold the cam steady as you tighten the nut.
